## Test Certificate

G104197 : Issue 1  
1 of 2  
Credit Card  
07/16/10  
08/11/10

Item - Ref: Coated Steel Panels Identified as 5/31-I and 5/31-II  
(Continuation of Ref #103470, Previously tested for 600 hrs)

Specification - ASTM B117-09, 1200 hours Total

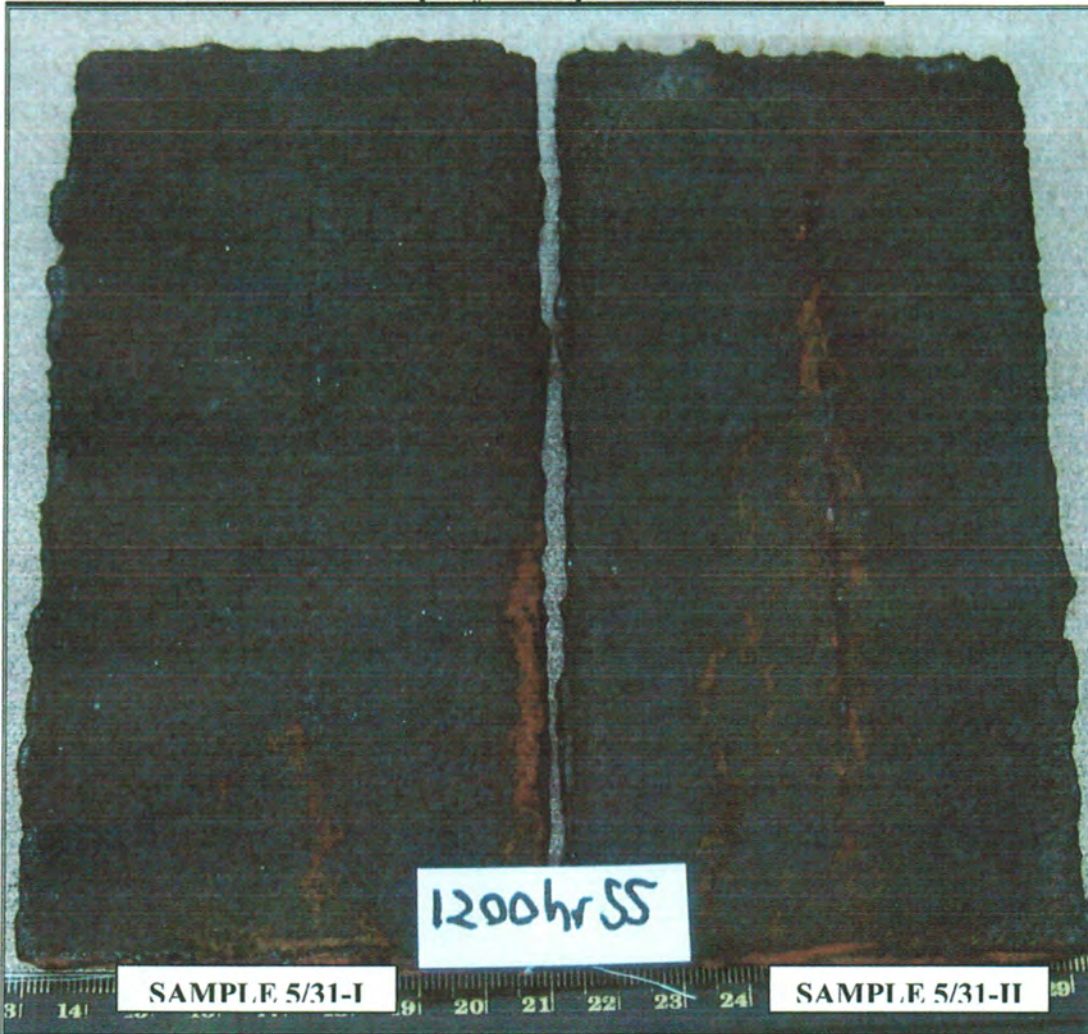
**Figure 1:** Photograph illustrating specimens after 1200 hours of salt spray exposure.

**Sample 5/31-I:** Showed no evidence of blistering, rusting or appearance changes on the significant surface away from the scribe. From the scribe and edges, no creepback/loss of adhesion was observed.

**Sample 5/31-II:** Showed trace amounts of red rust (0.03%) and a noticeable discoloration with no blistering on the significant surface away from the scribe. From the scribe and edges, no creepback/loss of adhesion was observed.

1. Red rust originating from the edges and scribe was excluded from the field corrosion evaluation.
2. The specimens were previously tested for 600 hours with no scribe. An additional 600 hours of salt spray exposure was conducted with a straight scribe.
